CHARLESTOWN CONSERVATION AREA

APPRAISAL

CONSERVATION AREA MANAGEMENT PLAN

Gray, Marshall & Associates
Chartered Architects

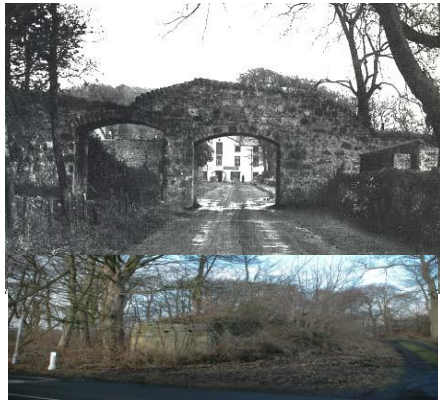
The Gin Head bridge c.1900, central part now demolished, but abutments still visible. (Simpson & Robertson)

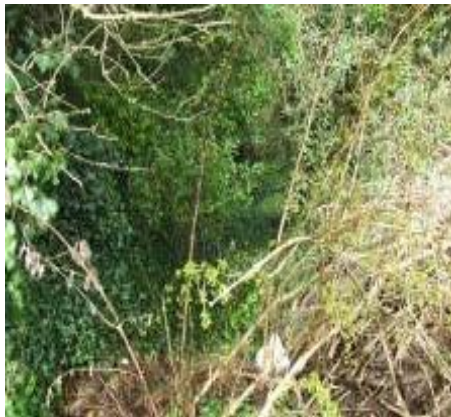
The route of the tramway west of Limebank, part of the Scheduled Ancient Monument.
View from path west of the limekilns, the route of an early wagonway (O.S. 1856).

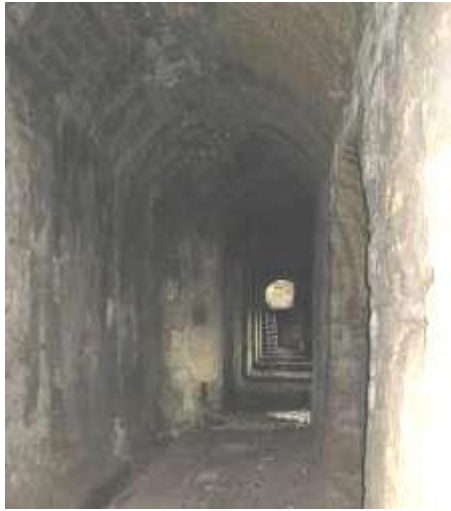
The Limekilns, A-listed and part of a Scheduled Monument

View of the interconnecting passage at the back of the kilns

The range is built into the bank and stretches in a row from west to east, their arches facing south onto the harbour. The kilns, of coursed dressed sandstone, are about 10m high, with access on top for feeding in the limestone and four drawholes near the bottom for removing the quicklime. There was capacity for 200

tons of limestone per kiln, but kilns 13 and 14 could take up to 500 tons. A vaulted passage connects the kilns. The high retaining wall visible on the east side gives an indication of the scale of the complex and at ground level the arches, vaults, and fireplaces are an evocative reminder of this once hot, noisy and crowded site of lime production. The kilns proper are not visible and the complex is currently closed off, but limited viewing access is available on East Harbour Road.

A detailed examination of the limekilns was not possible, but clearly conservation work is necessary. Heavy growth of vegetation on the masonry was noted. Roots will have disturbed the pointing and allowed moisture to penetrate. Archaeological remains are likely to be extensive on this site and safe access is also a key consideration. Conservation work to Kiln 11 was undertaken in recent years under the auspices of the Scottish Lime Centre and Historic Scotland.

“The project has secured the fabric of Kiln 11 and improved access, but, at present, the other kilns remain in a derelict condition.”

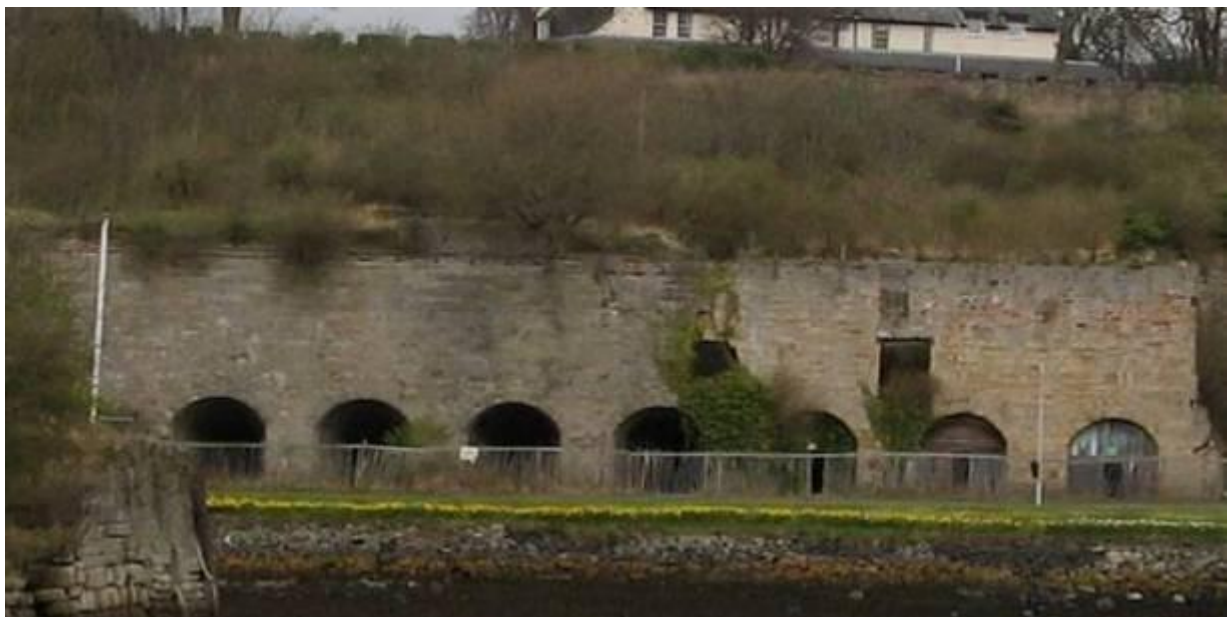
The limekilns seen from the outer harbour

Charlestown Harbour, B listed The Harbour is a complex of structures built in several phases, directly in front of the limekilns. The sickle-shaped (north-east) inner pier, built by the 5th Earl of Elgin, is roughly of the same date as the earliest limekilns, that is, the early 1770s. The squared quay to the west resulted from the creation of a railway embankment and provided further shelter and mooring for the inner harbour (mid 19th century). Two long rounded piers, from about the same period, form the outer harbour. Expansion to the east led to the building up of the east wall and the creation of the ballast bank between 1850 and 1870, forming a further harbour on the east side. At its peak the harbour was used not only for industrial transport (lime, coal, sand ballast) but also for passenger steamers between Granton

The Harbour is constructed of undressed stone as a core, with coursed or dressed sandstone blocks as facing, laid either horizontally or vertically, sometimes in battered courses. The quaysides are now mostly rough underfoot, with part paving/infill, a mixture of broken rock and soft topping. The Harbour is part of the Broomhall Estate.

The condition of Charlestown Pier, B listed, and of high historical, archaeological and social significance, is given as 'Very Poor' in the Register of Buildings at Risk. The damage to the stone faces and embankments seems to date from the peak period of ship-breaking in the 1920s and '30s. The condition of

the east bank and inner harbour is described in detail in the Report of the Public Local Inquiry (2006) into development at the Harbour, section 5.3, ...“significant parts of the harbour and Ballast Bank were showing significant signs of deterioration, and if overtopping and washing out of the core were not addressed, in time this would lead to the total collapse of the structure.” The Building at Risk Register specifically excludes the Inner Harbour from the At Risk entry. Historic Scotland has advocated a 'conservation based repair scheme' for the entire harbour (*Charlestown Harbour Planning Appeal* (2006) Precognitions, 4.3) and Fife Council has stated its support for repair and improvements:

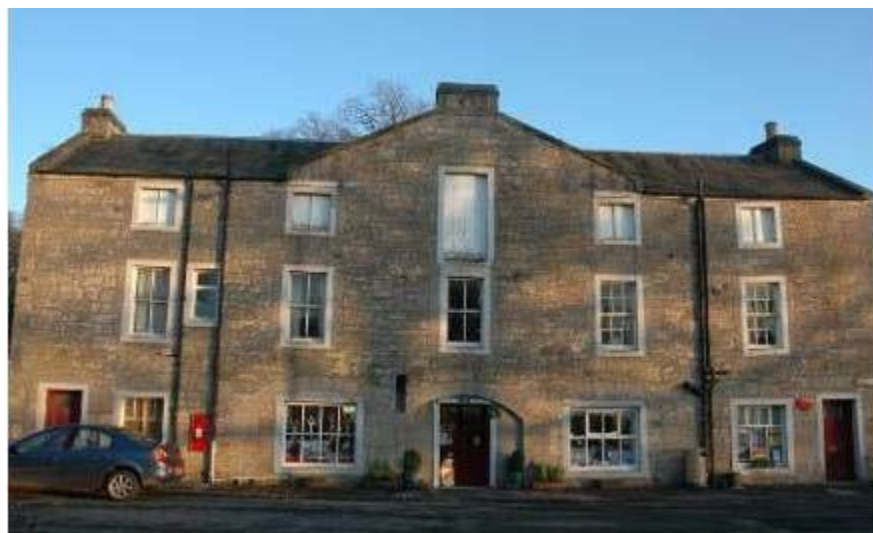
Left: The west elevation of the Sutlery. This had a bell (to call the workers) on top of the central section until the 1930s. Right, top: The groove for the bell-rope can be seen in the stonework left of the central door. Right, bottom: The belfry is

seen in this historic photograph (no date, Simpson & Robertson).

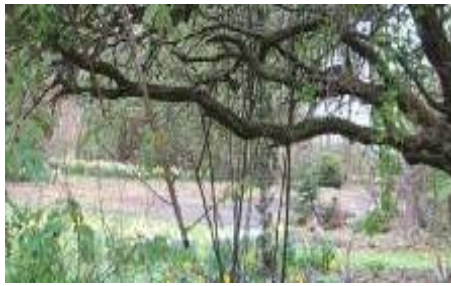
The site of the former station is visible in the clearing.

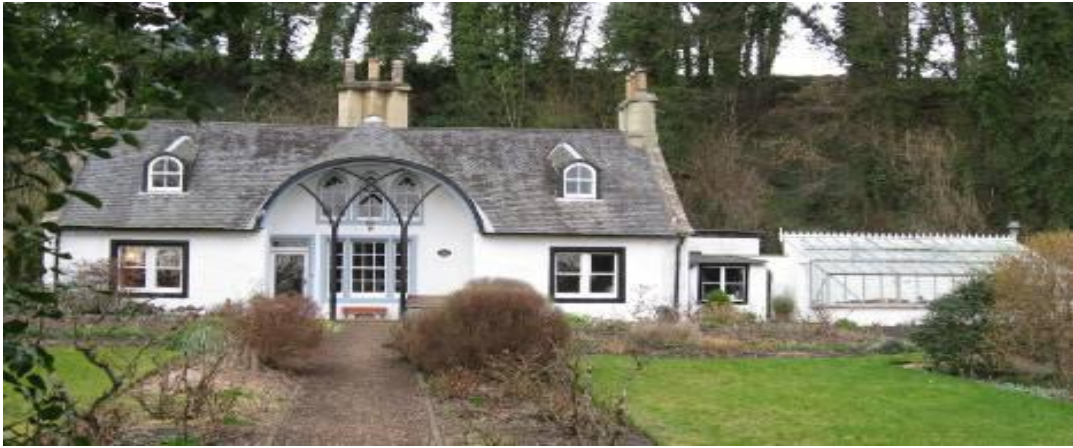
Easter Cottage, principal elevation

Easter Cottage, B listed Single storey, three-bay. It is thought that this distinctive house, in *orné* style, may have been built for the manager of the limeworks. Several features are notable, including the hood-shaped section of slate roof forming an entrance canopy, the slender interlacing columns, the three Gothick pointed-arch windows with Y tracery, the diagonally-set chimney stacks with linked shafts. The glass conservatory to the east appears on the 1914 O.S. map.

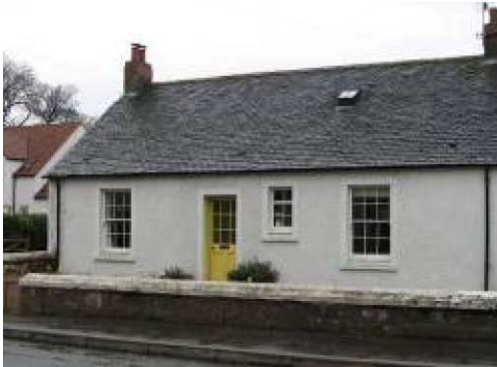
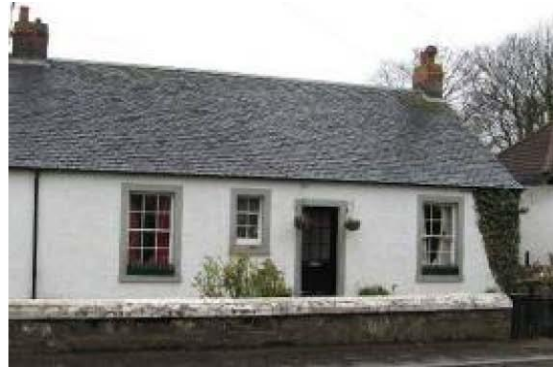
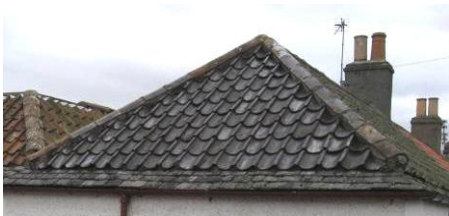
Black glazed clay pantiles with slate easing on South Row

Roofs are typically pitched, with either traditional slate roofs or clay pantiles, slate easing and clay half round ridge and hip tiles. The pantiles were sometimes glazed black to resemble slate, still seen on several cottages (eg. on South Row). Gables to the terraces are mostly piended. Open verges are more common here than on the vernacular houses in neighbouring Limekilns. Some of the larger buildings have plain skews (eg. Camsie House). Nineteenth century houses such as the Old Schoolhouse and Limebank have timber bargeboards and exposed rafters, a typical period detail. Otherwise bargeboards are not a traditional detail in this area.

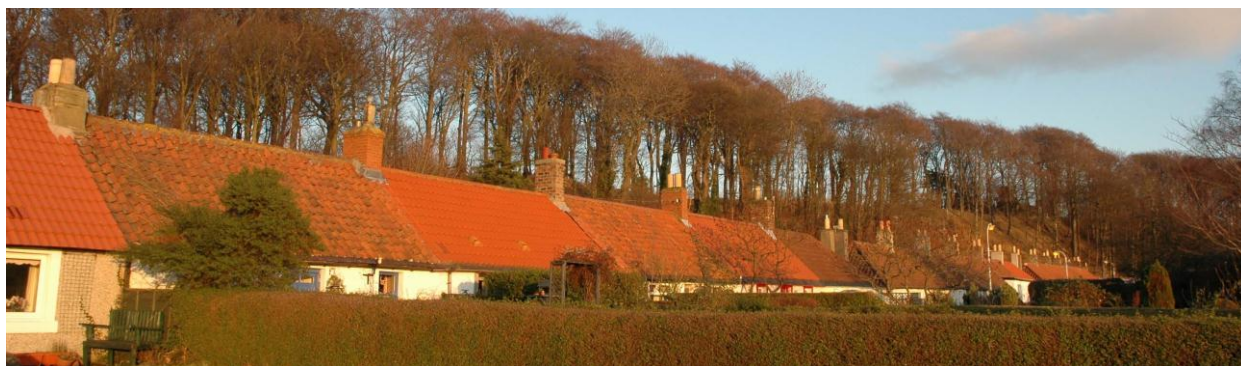
View along North Row, east end

There are relatively few dormers and rooflights in Charlestown. Large areas of uninterrupted slate or pantiles is the norm (see view of North Row below). Dormers form part of the original design and Gothic styling of the Schoolhouse. Traditionally proportioned and detailed pitched dormers are seen on the upper storeys at 4 and 9 North Row and the Old Inn (south elevation). Box dormers are not traditional. The catslide round-headed dormers of Easter Cottage are unusual and form part of its charm.

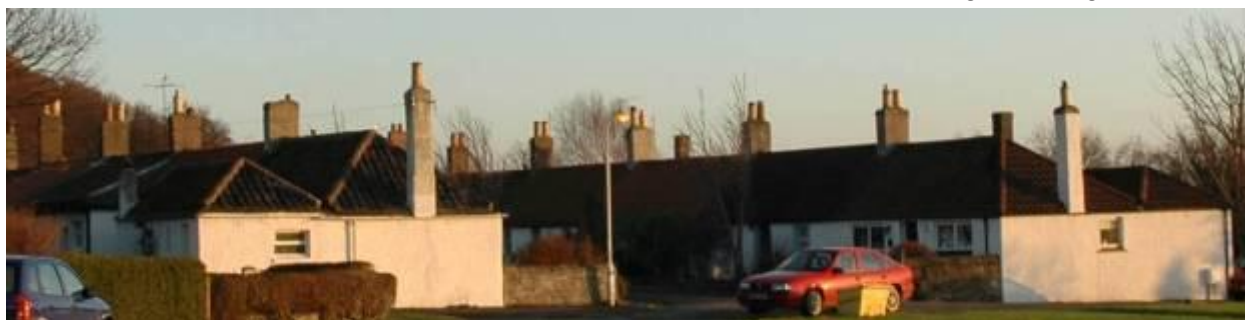
The chimneys are an important element of the view towards Double Row.

Chimney stacks and chimney cans form a distinct part of the skyline in the Conservation Area. These are commonly coped wallhead, ridge or, at the end of a terrace, slender gable stacks. The tall harled stacks at the corner of North Row are dramatic in proportion to the height of the houses. Some have been re-built in brick, to a lower level (notably the east blocks of North Row), but most

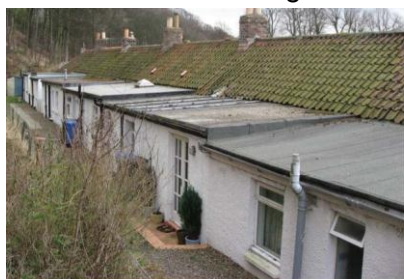
The flat-roof extensions at the back of North Row, seen from the elevated garden plots.

Extensions to the back of North Row are flat roofed and follow a common building line. On other rows extensions are parallel to the cottages, the two forming an M roof. South Row has many outshot extensions.

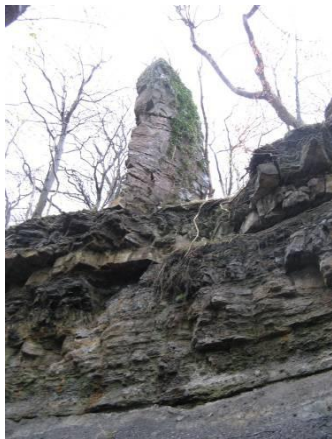
West Quarry (outwith the current Conservation Area) The disused quarry has been left to grow wild. Vegetation now covers the quarry floor and only part of the quarry face is visible. Remains of the engine house and the base for the steam engine give hints of past industrial use on the site. The Cairns housing and West Road can be seen through the trees in winter. This is a peaceful natural space.

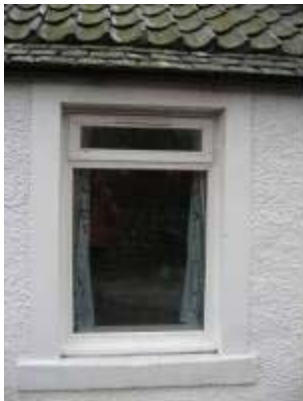
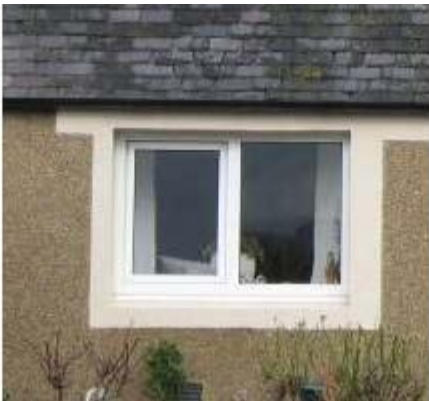
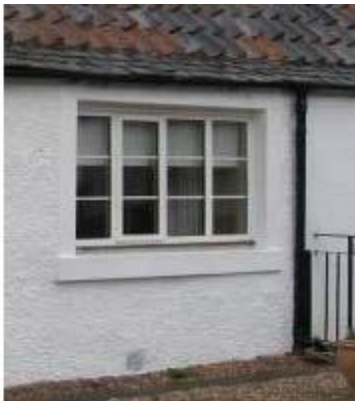
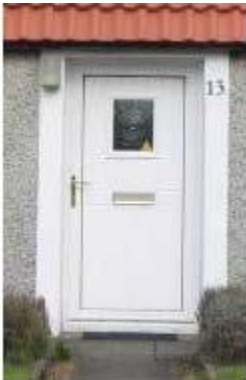
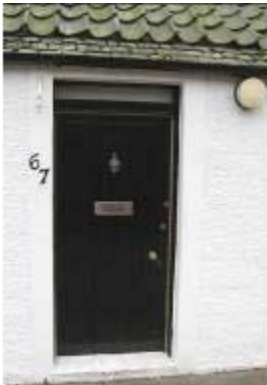
A range of inappropriate replacement windows, not matching original opening sizes, materials or design.

replacement doors and ironmongery, not matching original patterns, materials or styles.

A range of unsuitable

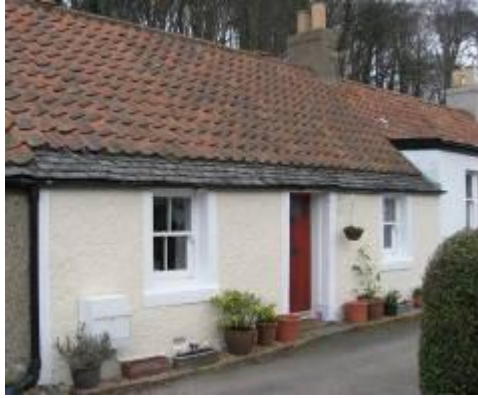
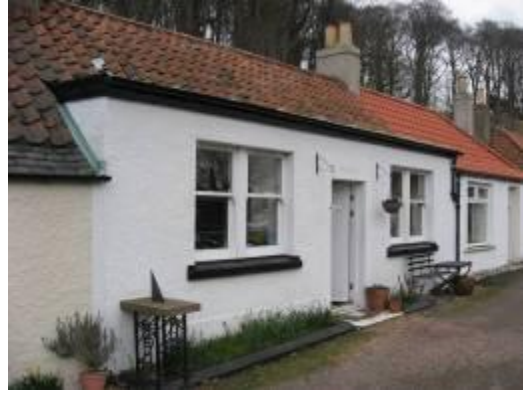
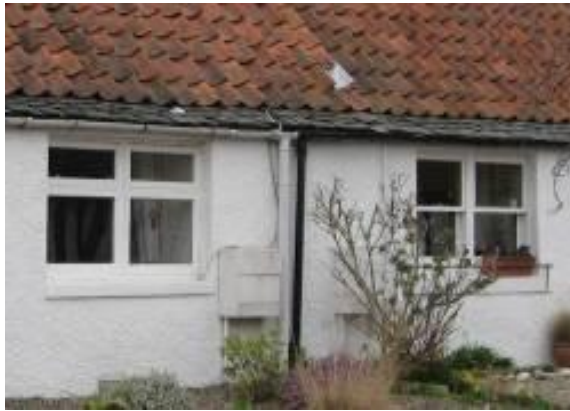
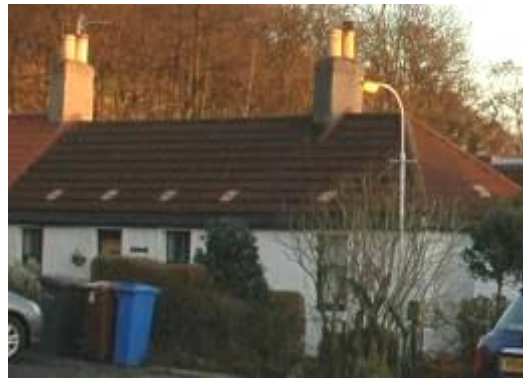
Compare this elevation with that of the neighbouring house
This house has been extended up into the roofspace and

(right) the window openings heightened.

Compare the original style windows on the right with replacements on the left. Note also the two prominent meter boxes.

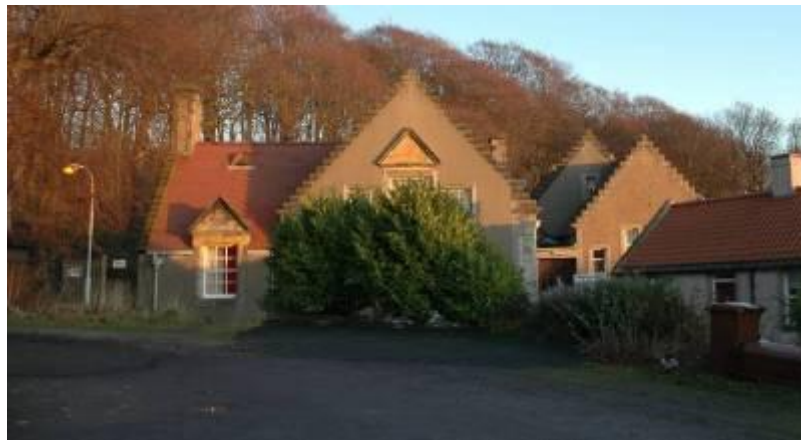
Blocked gutters and water seepage into the wall was noted on the north elevation. The timber windows need re-painting. Annual routine maintenance and checks should be carried out on a building such as this, including the rainwater goods and wallhead copes. The fine front elevation of the Queen's Hall – with the tripartite window centrepiece and inscribed tympanum and lintels -is marred by the dense evergreen bush growing in the parking area (see photograph below). Wheelie bins along here also detract from the setting. A little re-organisation of the open space would improve this area.

The west (principal)
elevation of the
Queen's Hall
A ground floor window
at the Sutlery

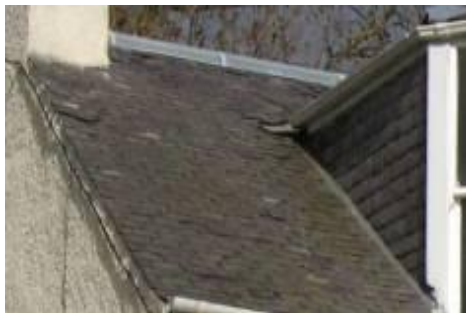
The Scottish Lime Centre

The thick lime harl on the curved wall, now emblematic of this building and its use, is a recent addition. The roof ventilators, fitted in as 'catslides,' also date from the conversion.

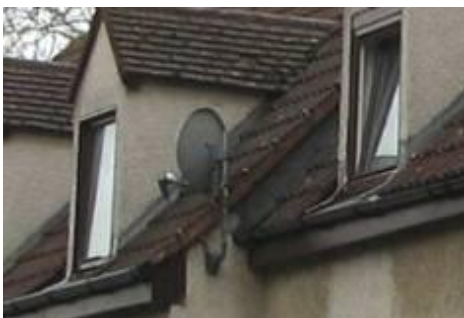
The Cairns

This post-war development of houses is inspired by the rows at the Green, with details such as a ‘green’ in front, open verges, pantile roofs, pedestrian access to the back, gable chimney stacks. The layout too is logical and the proportion of the single storey dwellings at the end is similar to that at the Green. Some of the detailing is drawn from International Modern eg. casement windows, the geometric door surround. This is a unified group, with character and distinct local identity, formally unaltered on the front elevations. The main change has been in replacement windows and

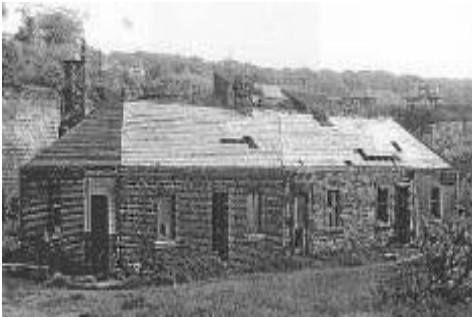
A front porch on South Row

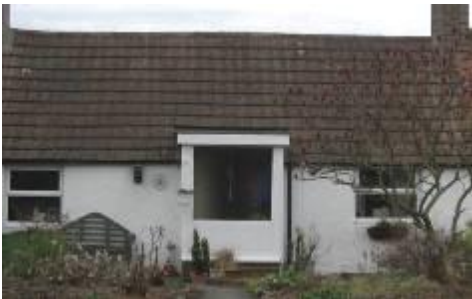
An extension on South Row
merit, its replacement is even less pleasing. An extension and re-build such as this presents an opportunity for the best of contemporary design and an appropriate response to context in terms of materials, proportions and composition.

Replacement of natural slate and traditional lead flashing with concrete tiles may have been regarded as a 'modern approach' at one time, but is now considered as less satisfactory. The chimney stacks are conspicuous by their absence. The greatest changes have been to the size and position of the openings. These were originally fairly small, vertically proportioned sash and case windows, spaced regularly across the front. This has been radically altered and now the openings are neither vertical, sash and case, nor regularly placed.

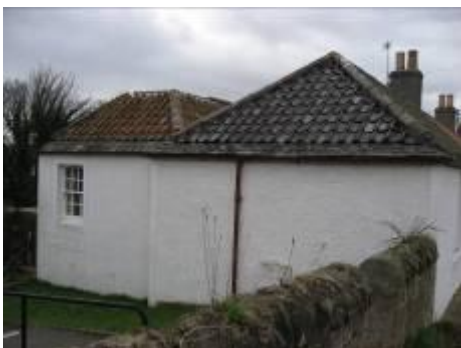
Harbour Cottage, the former Customs House on East Harbour Road, has been radically altered.

Harbour Cottage 1967 (RCAHMS) Harbour Cottage now
